QA-84
Bloomfield
Centreville vicinity
Private

INVENTORY FORM FOR STATE HISTORIC SITES SURVEY

Bloomfield

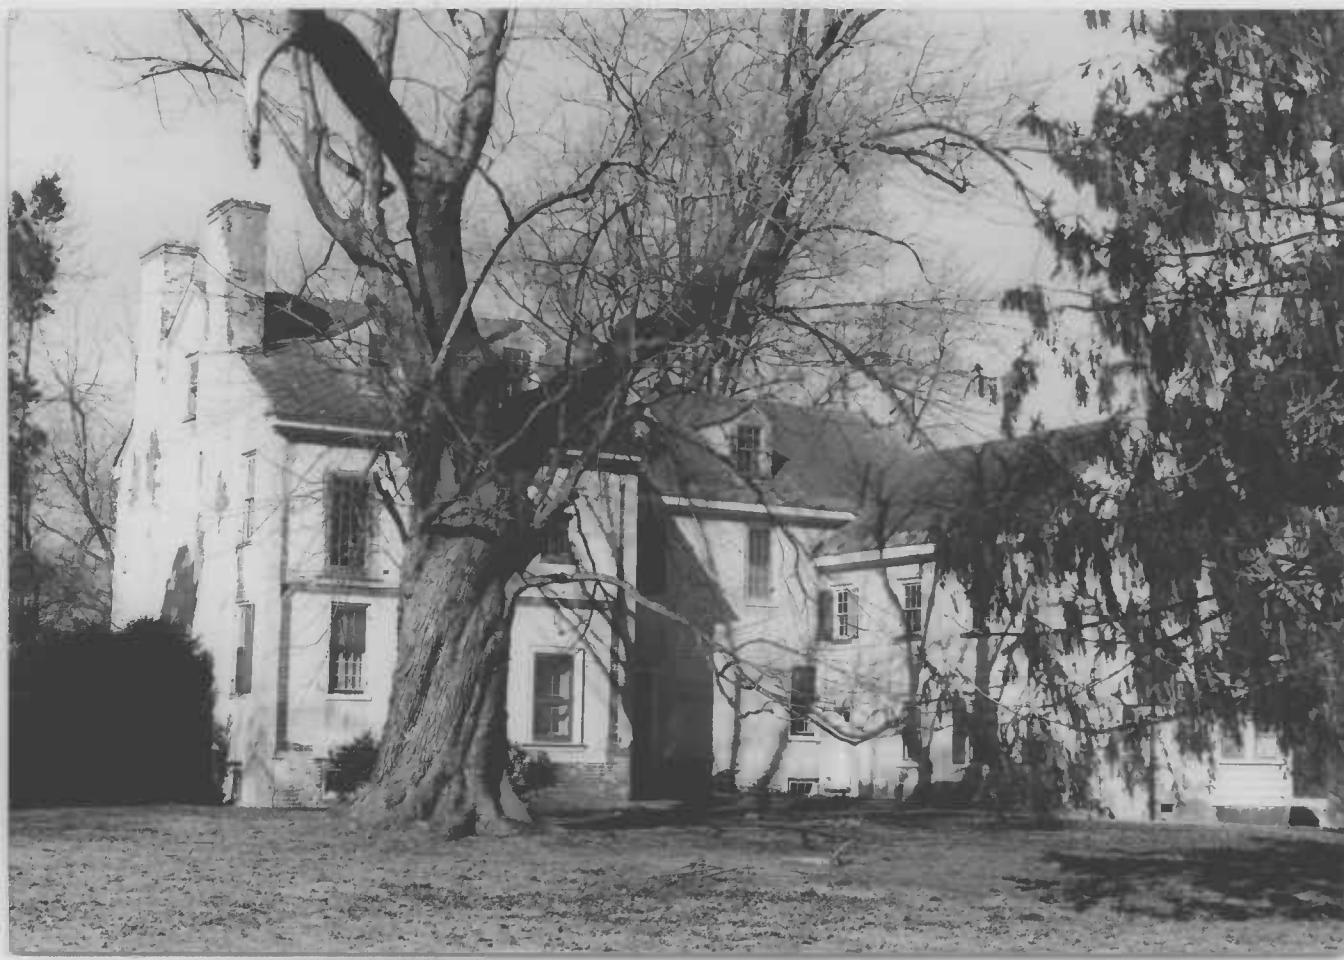
On the rear facade, several alterations have occurred. In the 1916 photograph, there is a two story porch across the rear facade, but this was demolished in recent years. The fenestration is similar to the front facade, but varies in several respects. There are only two cellar windows, one each in the south and center bays. The first floor door is relatively simple, and lacks an arched opening and transom. On the second floor, a door to the second floor porch remains in the south bay, and the upper sash of the north window has been blocked up and eliminated. Two six-over-six dormers remain in place on the third floor.

QA-84 Bloomfield
Centerville vicinity, Md.
Orlando Ricout V, 1978 (MHT)
Rear elevation, camera facing NW

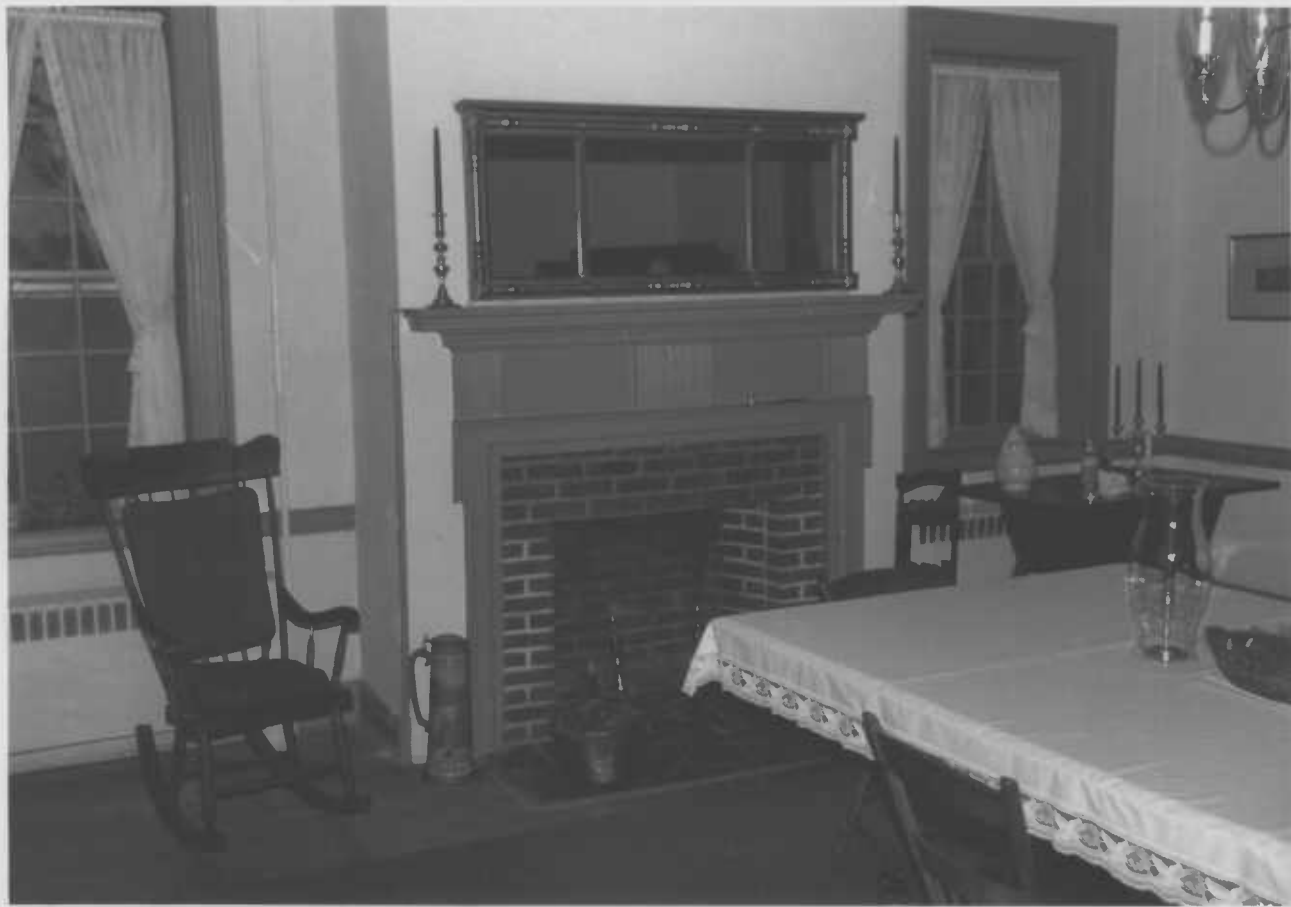
The first floor of both the hyphen and the rear wing have been completely altered, and little remains to suggest the early appearance. The north wing, however, remains basically intact on the first floor. It presently consists of a single large room with a fireplace on the north wall. A handsome Federal mantel and virtually all of the original trim remain in place. It is not clear whether this was always one large room, but the dimensions of the wing combined with the elaborate mantel suggest it probably was, and may have served as a rather formal dining room and parlour.

QA-84 Bloomfield
Centerville vicinity, Md.
Orlando Ridout V, 1978 (MHT)
Interior, North wall of wing

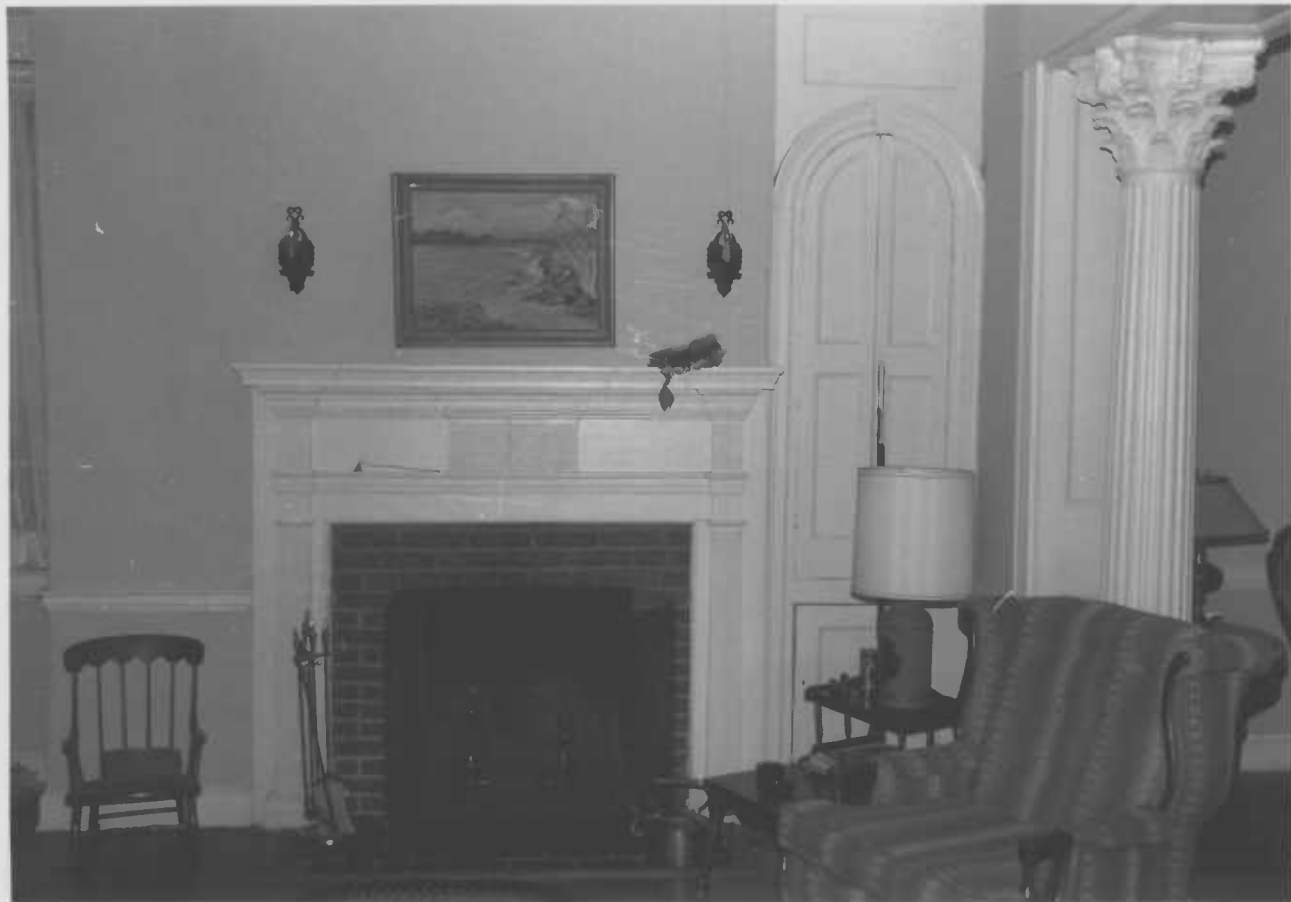
GA-84 Bloomfield, SE Parlor
Centerville Va.

Both parlours have fireplaces on the center of the south wall, and both fireplaces are set off by splendid Federal mantels. In the east parlour, there is an original built-in cupboard with paneled doors and an arched surround to the right of the fireplace. Handsome molded baseboard and chairrail encircles both rooms, and all of the original window architraves have survived. The remaining original door opening and all window openings have paneled soffits and jambs.
